Regent Road Retrofit Final Report

Report prepared for the Skipton Building Society by: Dr Kate Morland, Dr Adam Hardy and Dr Alice Owen

Leeds Sustainability Institute, Leeds Beckett University and The University of Leeds

11 March 2025

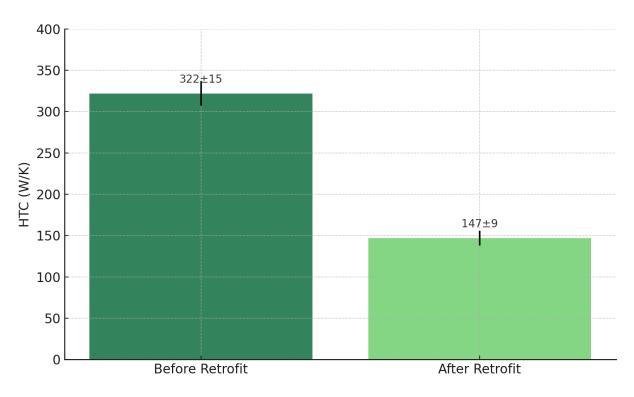
Figure 3. Measured HTC of 49RR, before and after EEMs.

Figure 3 shows the HTC of the property before and after retrofit. The pre-retrofit HTC of 322±15 W/K is relatively high compared to modern homes, which typically have HTCs less than 100 W/K. However, for a home of this age and construction, an HTC of this value is to be expected. The retrofit measures have more than halved this figure, reducing the HTC by 175±17 W/K.

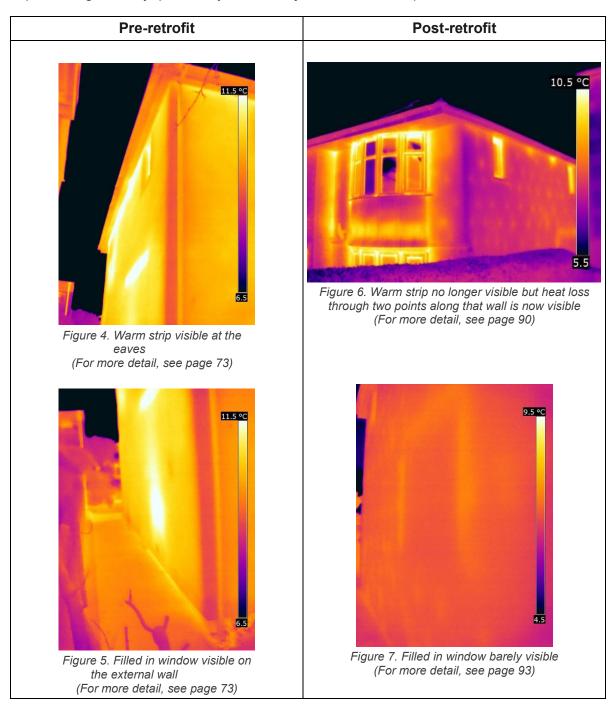
On the North side façade at the eaves junction, two warmer spots remain (Figure 6), possibly the sites of old air bricks. These are only now visible as the rest of the eaves junction has improved significantly, previously the whole junction showed up as warmer.

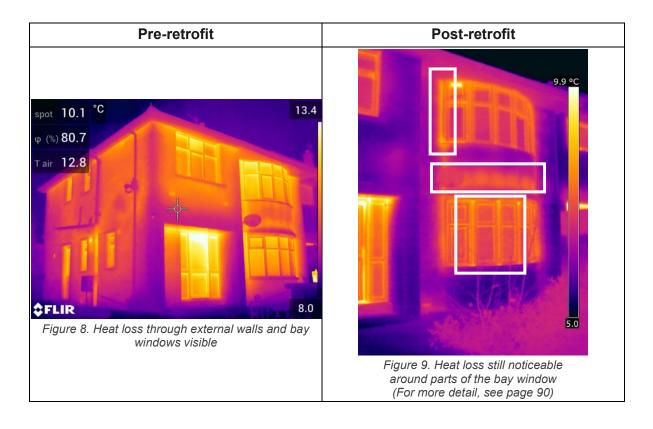
Post-retrofit, issues were noticeable around the bay windows in three areas (Figure 9). First, warmer strips at the jambs are potential thermal bridges, with the edge frame units positioned in line with the outer leaf of the external wall rather than with the cavity and insulation layer (area illustrated by top white box). Second, the mullions between each window glazing unit appear warmer than the actual window frames (see bottom white box). Last, the bay wall appears warmer than other external wall surfaces at intermediate floor level, but not at the ground floor level (see middle white box). However, it should be noted that these issues appear to all have existed pre-retrofit as well, but they were harder to see as heat loss through the external walls was greater, masking the effect. As the walls are now better insulated, these areas of heat loss are clearly evident (Figure 8).

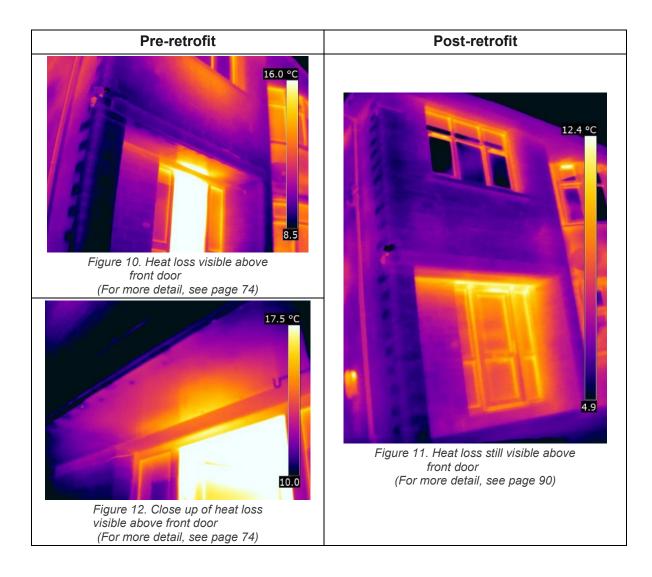
Prior to retrofit, warmer areas were visible above the front door (Figure 10 and Figure 12). Post retrofit, this warm strip remained (Figure 11) and still displayed the warmest surface temperatures visible on the front elevation (besides warm air exiting through the trickle vent in the upstairs bay window). However, the absolute temperature of this strip was lower postretrofit.

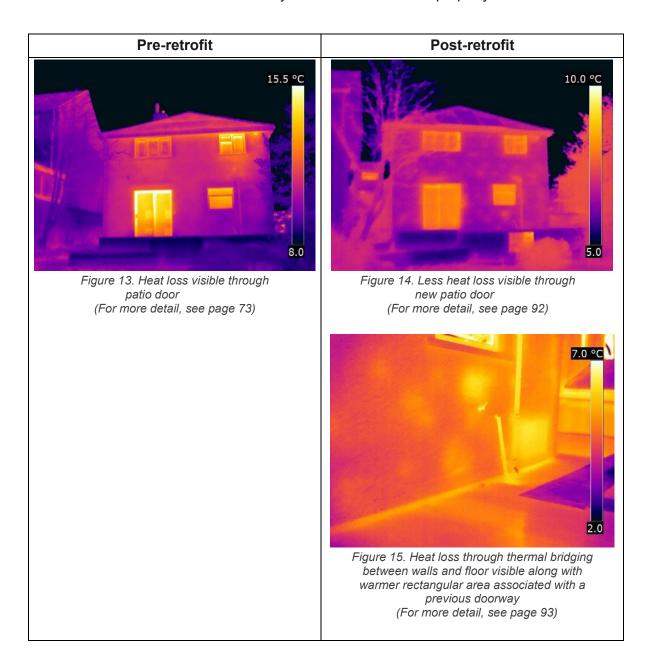
The previous patio door frame appeared to perform particularly poorly from a thermal perspective (Figure 13), the replacement performed markedly better (Figure 14). Some thermal bridging was observed around the ground floor perimeter (Figure 15), but again this did not appear excessive. Interestingly, a warmer area became visible on the rear elevation, where there appeared to have been a previous doorway, now filled in (yellow rectangle on Figure 15). This area was likely missed by the cavity wall insulation, though its small area means it will not contribute considerably to the heat loss of the property.

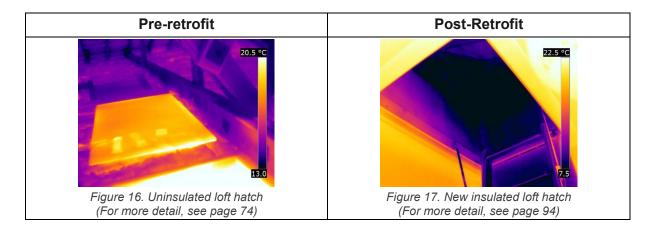
Pre-retrofit, the loft hatch was uninsulated and unsealed, appearing to consist of just a sheet of MDF (Figure 16). The loft hatch was replaced with a proprietary insulated hatch, with boxing to allow insulation to be properly fitted (Figure 17).

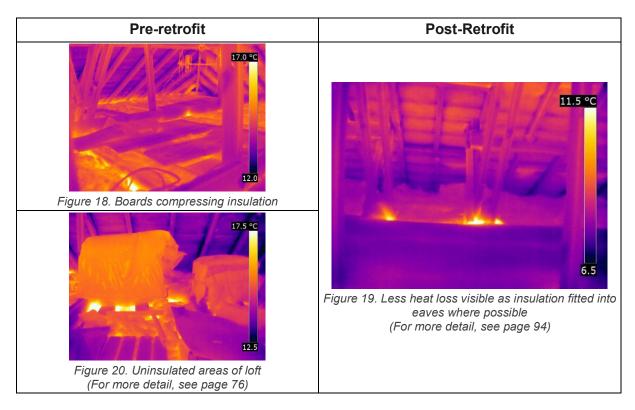
Pre-retrofit, loft insulation was compressed in many areas by boards lying on the surface (Figure 18). Breaks in insulation occurred where deeper joists ran and where the blockwork for internal partition walls extended through it. The water tank above the bathroom was covered with a polythene covered insulation quilt, but there appeared to be no insulation beneath it. Insulation had been moved away from the bathroom downlighters to prevent them overheating, consequently leaving areas of uninsulated ceiling (Figure 20).

Post-retrofit, with the water tank now removed and new decking covering the downlighters there was little to observe in the loft. The insulation appeared even and fitted right up to the eaves, with just a few warmer areas around the ceiling junctions with trusses (Figure 19).

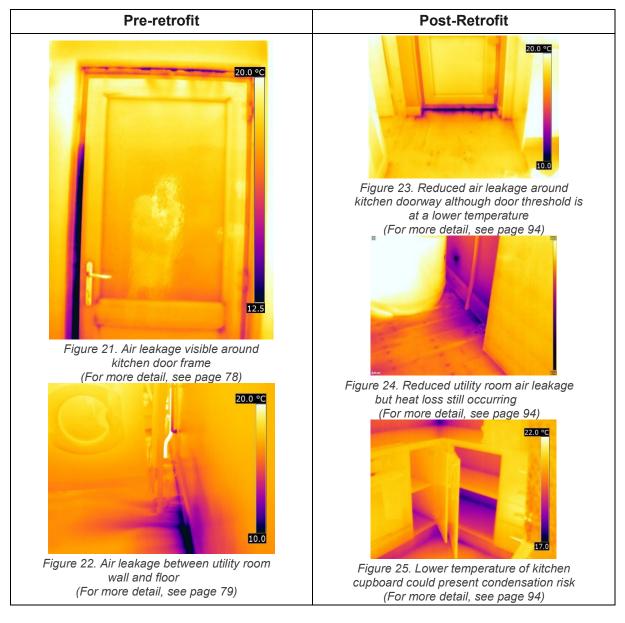
Pre-retrofit, air leakage was detected around the kitchen door frame and between the door and frame (Figure 21). Post-retrofit, this was considerably reduced (Figure 23). The rear threshold displayed the lowest surface temperatures in the kitchen, potentially low enough to be a condensation risk without adequate ventilation. Likewise, the external floor/wall junction in the utility room showed a major infiltration pathway pre-retrofit, with air emerging under the skirting flowing underneath the lino floor covering (Figure 22). The retrofit appears to have reduced this impact, though the external floor/wall junction still appears noticeably cooler (Figure 24).

Interestingly, the interior of one of the cupboards shows low surface temperatures (Figure 25). This location corresponds to the suspected filled-in doorway (see Figure 15) which appeared as much warmer in the external thermography. This effect was not picked up on in the pre-retrofit survey, suggesting it is a new phenomenon. As the surrounding external wall is now warmer, this cupboard, which is against a colder part of the wall may present a condensation risk if not well ventilated.

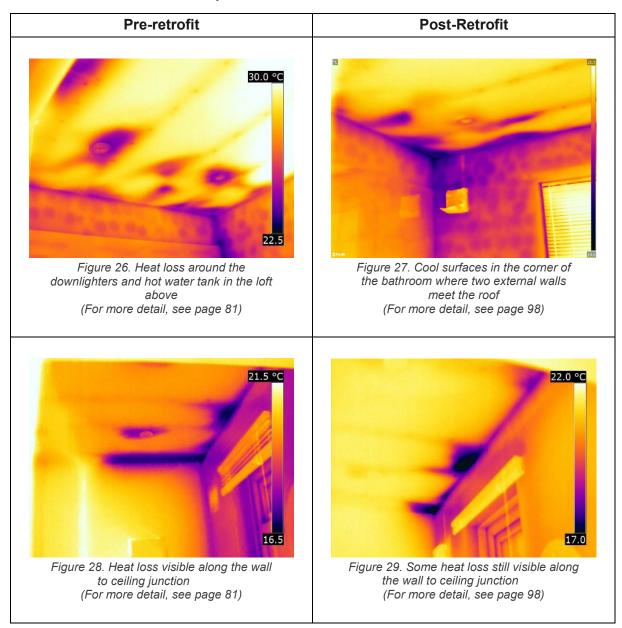
Pre-retrofit, the WC ceiling showed an uninsulated area around the downlighters and where insulation in the loft had been rolled back. Likewise, gaps in loft insulation around downlighters and underneath the water tank in the loft (see Figure 20) were apparent the bathroom (Figure 26 and Figure 28). Post-retrofit, the WC ceiling showed cooler areas at the eaves suggesting that while heat loss has reduced along this junction, the new loft insulation does not fully extend to the eaves (Figure 29 and Figure 19). Gaps in loft insulation around the downlighters and underneath the water tank in the loft had been resolved. The external corner in the bathroom is visibly the coolest surface area. This is not surprising as the shape of the hipped roof makes this corner extremely difficult to insulate.

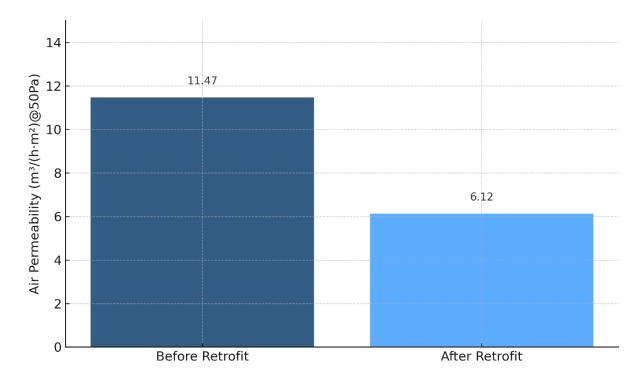
Figure 30. Blower door test results before and after retrofit.

One output from the blower door test is a flow exponent⁷, which can indicate what sort of gaps the air is escaping from. In 49RR, an exponent of n=0.607 was measured pre-retrofit. This value indicates that air leakage was dominated by direct paths through open cracks and gaps rather than permeating through materials as values of n<0.65 are generally assumed to represent buildings where direct airpaths dominate throughout the range of airtightness test measurement pressures. It was also noted that airtightness was slightly better under depressurisation than pressurisation, possibly due to the outward opening windows and non-draught-stripped loft hatch being pulled closed under depressurisation. Post-retrofit, the flow exponent had changed to n=0.677. This suggests that a lower proportion of the air leakage was now direct leakage through cracks and gaps in the fabric and a higher proportion permeating through porous materials and more complex leakage pathways.

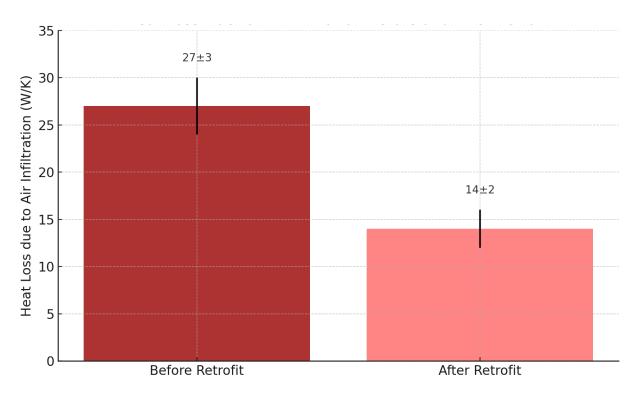
Figure 31. Heat loss due to air infiltration before and after retrofit

It is possible to convert a value of air permeability to an approximate value for heat loss attributable to air leakage⁸. On 49RR, this conversion results in a value of approximately 27±3 W/K. However, this conversion relies on several assumptions which, while correct as an average over many measurements, can vary considerably when studying a single home. Therefore, while individual values of heat loss derived from airtightness measurements can be a useful indicator, they should be treated with some caution.

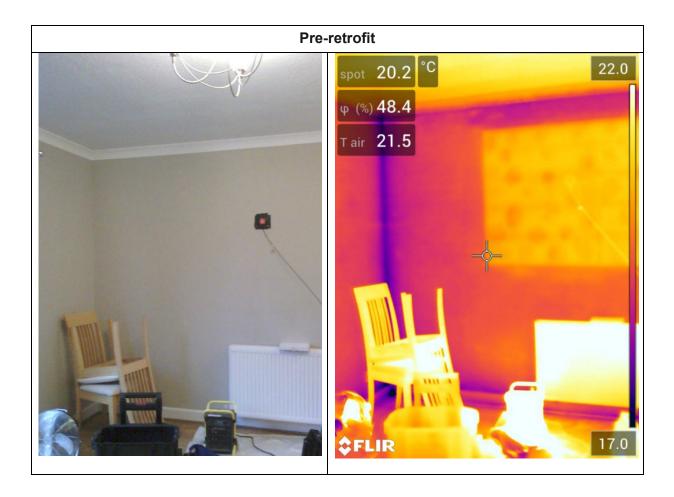
One plate was not included in the average above. This plate was placed on an area of dining room wall which in the past contained a window, as identified from the thermal images (see Figure 34, Figure 5 and Figure 7). The construction materials used when filling in this area have a better thermal performance than the rest of the wall, and a U-value of 0.9 ± 0.1 W/m²K was therefore recorded in this zone pre-retrofit. Despite being lower, the retrofit works were still able to reduce this U-value, and a figure of 0.3 ± 0.1 W/m²K was recorded post-retrofit.

Figure 34 - Thermal image of a window opening in the dining room, now filled in and plastered over (lighter area to the right of the image)

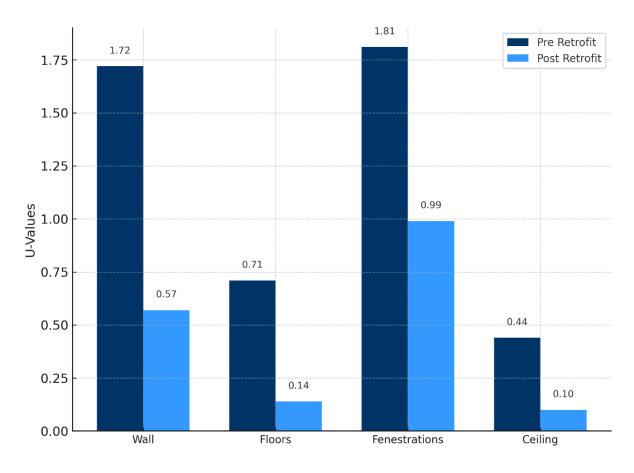
Figure 35. U-value summary

The improvement in overall heat loss was reflected in measurements on the individual heat loss though various elements. These are summarised in Figure 35. The U-values for the floor, ceiling, walls and fenestrations (windows and doors) fell by 80%, 77%, 67% and 45%, respectively. While the improvement varied depending on the element, each element achieved a significant reduction.

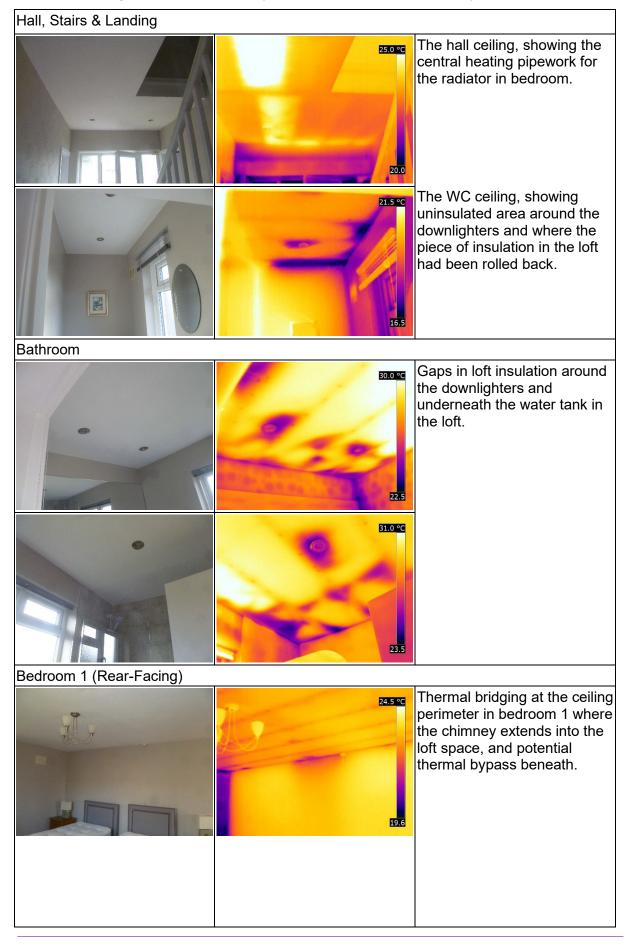
17.5 °C 12.5	The water tank above the bathroom was covered with a polythene covered insulation quilt, but there appeared to be no insulation beneath it. Insulation had been moved away from the bathroom downlighters to prevent them overheating, consequently leaving areas of uninsulated ceiling.
15.0 °C	Above the WC and bedroom 3 cupboard there were missing areas of insulation around the downlighters and where a roll of loft insulation appeared to have been rolled back to expose the plaster ceiling beneath.
13.0	
IB.0 °C

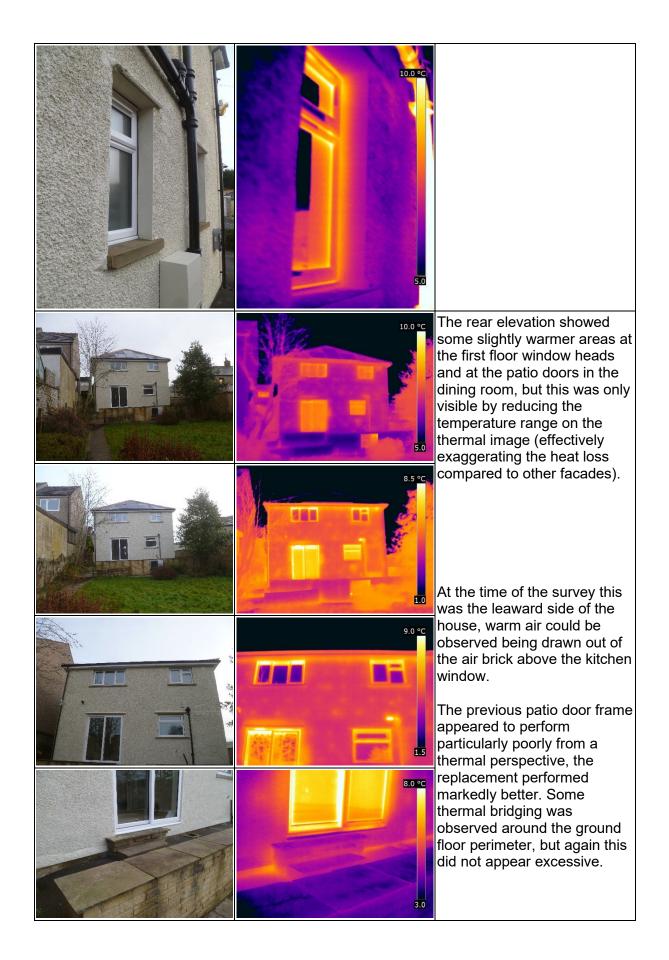
A warmer area was visible on the rear elevation, where a doorway appeared to have previously been but was now filled in.
11.0 °C	On the north wall where a window had been filled in at the dining room, there were previously warmer areas clearly visible at the lintel and jambs. These were now only visible by manipulating the thermal image to highlight the slight difference in surface temperatures.
9.5 °C 4.5	(17-Nov-2023)
