Regent Road Retrofit Final Report

Report prepared for the Skipton Building Society by: Dr Kate Morland, Dr Adam Hardy and Dr Alice Owen

Leeds Sustainability Institute, Leeds Beckett University and The University of Leeds

11 March 2025

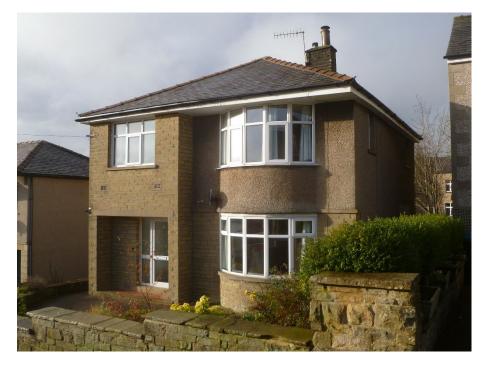
Figure 1. 49 Regent Road pre-retrofit, (November 2023).

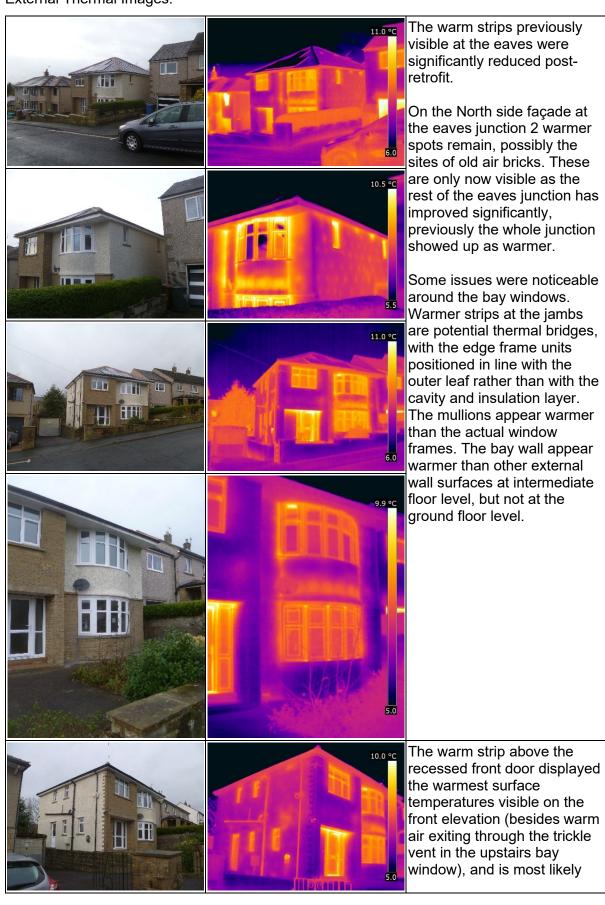
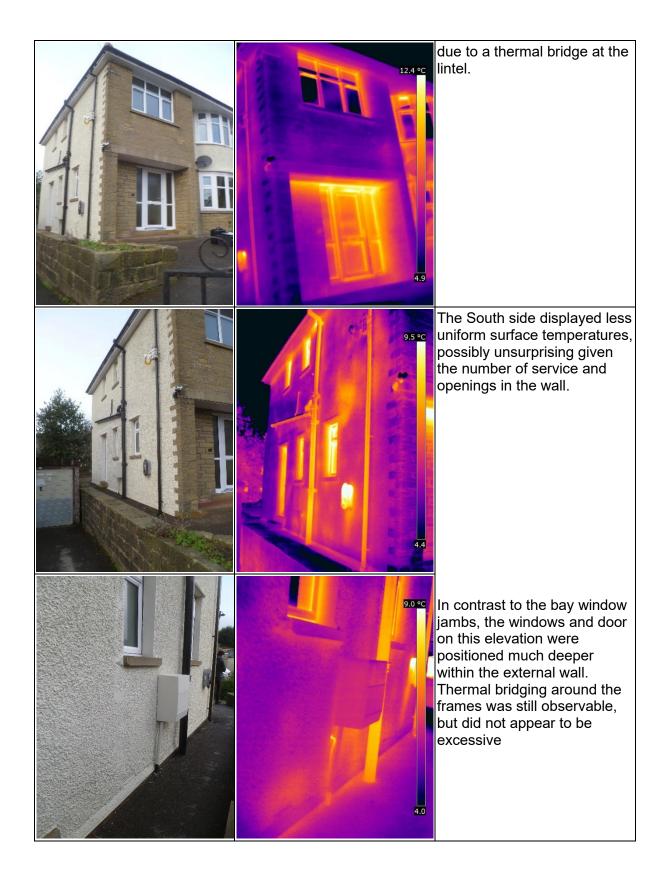
A warmer area was visible on the rear elevation, where a doorway appeared to have previously been but was now filled in.
11.0 °C	On the north wall where a window had been filled in at the dining room, there were previously warmer areas clearly visible at the lintel and jambs. These were now only visible by manipulating the thermal image to highlight the slight difference in surface temperatures.
9.5 °C 4.5	(17-Nov-2023)
